PROJECT PROFILE

PROJECT: Repairs To Valves

LOCATION: Germany

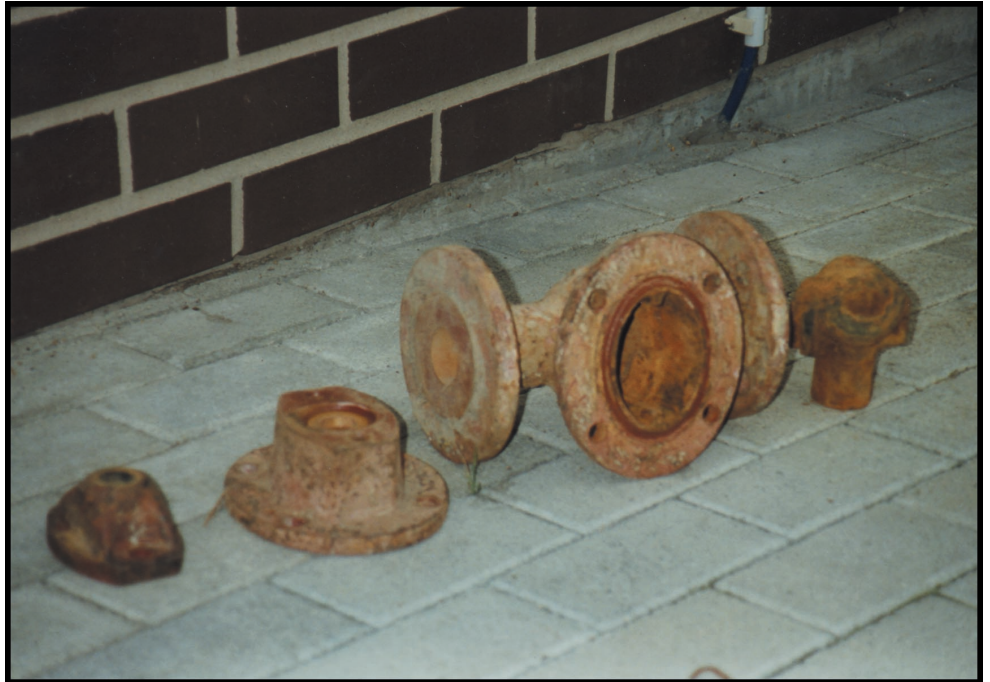
The valves in the water pipes of the water supply network serving a small city in Germany were being replaced every 5-10 years due to the aggressive soil type in which they were positioned. This was proving very expensive, so an alternative to this was required.
