PROJECT PROFILE

PROJECT: Waste Water Treatment Plant
LOCATION: Latvia

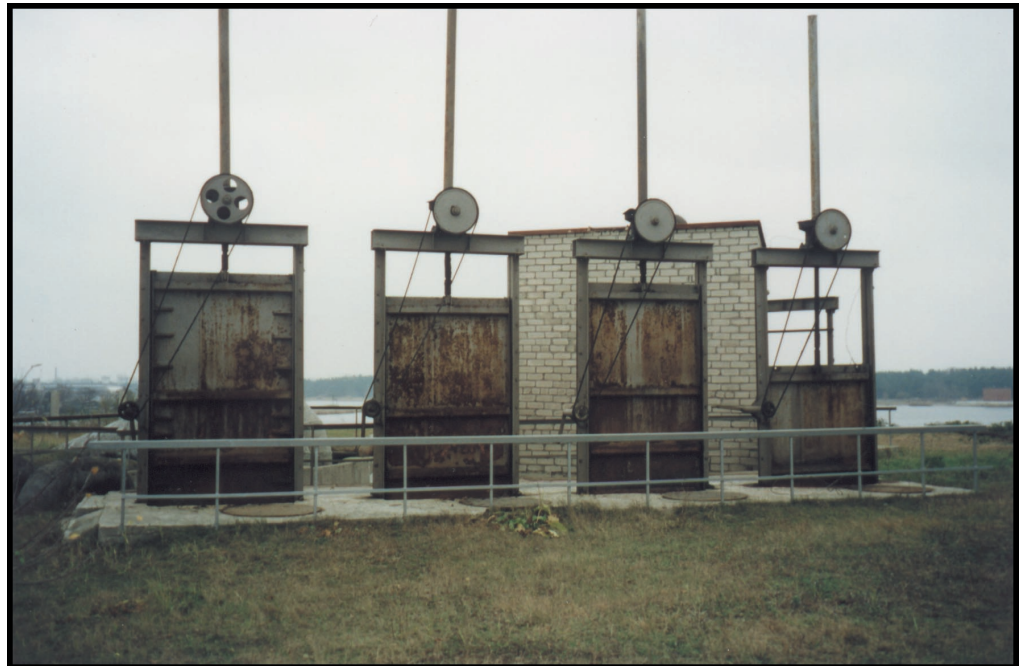
The external surfaces of the metal valves and waste water outlets had gradually deteriorated over a period of time.

Rust was now showing through extensively and they were therefore in need of a complete upgrade to prevent their condition deteriorating to the stage where they were beyond repair.

The surfaces were first of all grit blasted to remove all rust and poorly adhered coatings.

The entire surface was then coated with one coat of Corro-Tech GP, followed by one coat of Chemi-Tech EP which gives excellent protection in this type of working environment.
